Safety Alert

Jammed Cryogenic Sample Storage Rack

October 2020

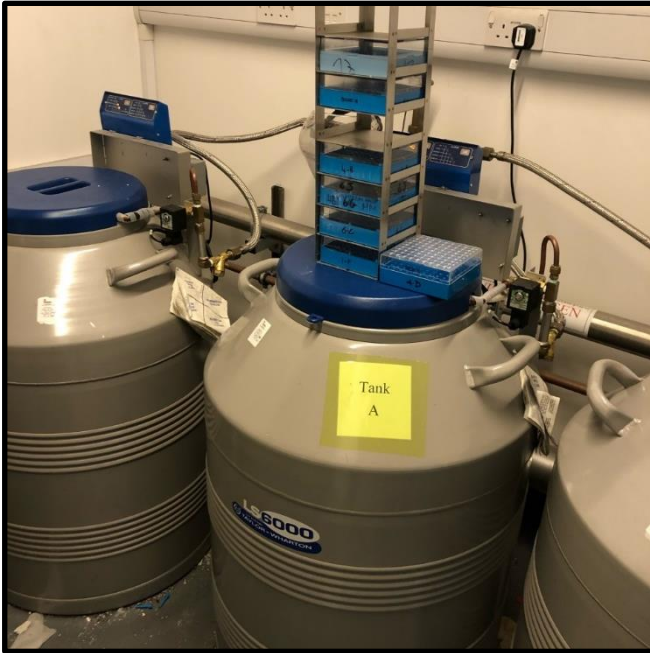
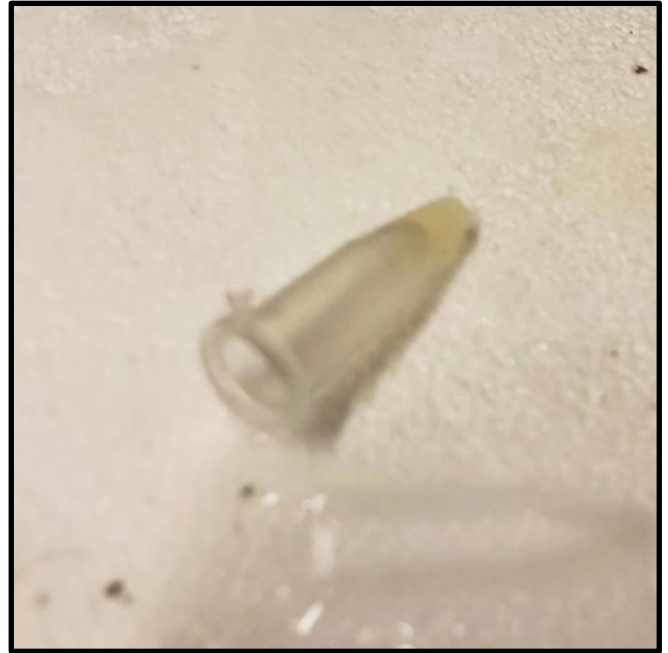
During the routine inspection and servicing of a liquid nitrogen storage tank it was found that a sample storage rack was stuck inside and would not release from the tank. Further examination confirmed that a metal locking pin had fallen out of position and become jammed against the storage rack placing it under tension and preventing it from being easily released.

- If sample vials or pieces of equipment are accidentally dropped into liquid nitrogen tanks this should be reported straight away to a responsible person to ensure that they do not pose a hazard to other users.
- Samples must be stored in appropriate cryogenic vials. Snap top vials should not be used due to the risk of over-pressurising on warming to room temperature. All samples should be clearly labelled with the date, contents and the name of a responsible person to ensure they can be properly identified in the event of an accident.
- Care should be taken to ensure that all contractors working in laboratories and sample storage areas receive a suitable safety induction to ensure they are aware of any required safety precautions in specialist areas.
