Safety Alert

Bunsen Burner Safety

March 2021

Fire in Wolfson Link Building (March 2021)

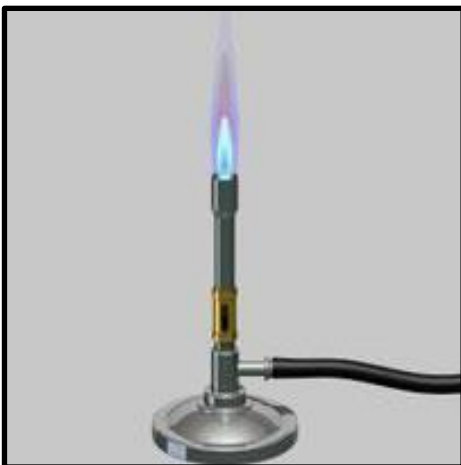
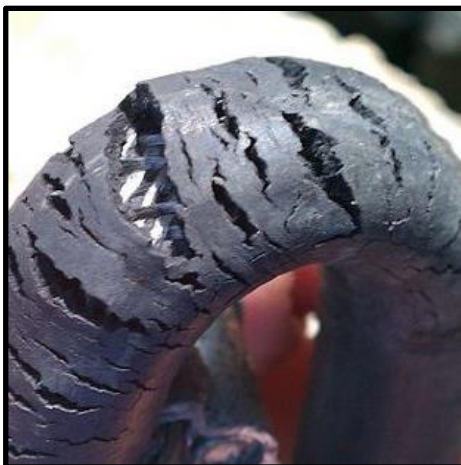
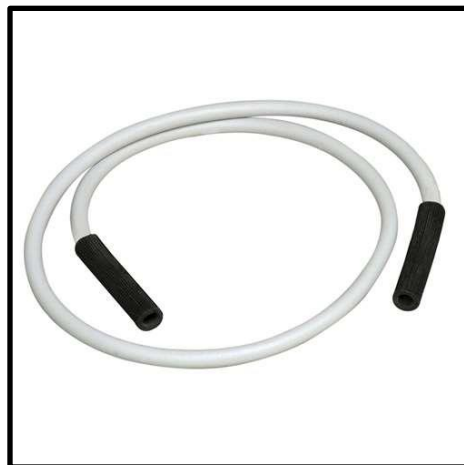
A fire recently occurred in one of the research laboratories in the Wolfson Link Building during use of a Bunsen Burner. Flammable gas was released from the burner which subsequently ignited causing a fire that spread rapidly. Fortunately no-one was hurt and due to the actions of the emergency services the fire was contained to the laboratory. However, the damage caused to the laboratory was significant and the consequences could have been much more severe.

- Carry out an immediate inspection of **all** Bunsen burners and their associated tubing (including those in storage) and remove from service any that are found to be damaged, in poor condition or fitted with improvised (or inappropriate) tubing. This inspection should include:

- Condition of the main body of the burner (i.e. is it rusty, are any parts loose, is the collar seized?)
 - Condition of the tubing (check for perishing, cracks, holes, pinch points or any other defects)

- Check that the tubing is made of an appropriate material (e.g. neoprene, natural rubber)?
 - Does the tubing fit securely on the gas taps and the burner?

- Introduce a programme of regular inspections of gas burners, tubing and any other accessories and encourage laboratory users to inspect gas burners before use to ensure they are in good condition. If there is a need for tubing to be replaced, ensure the replacement is made of a suitable material (e.g. neoprene) and consider purchasing tubing with reinforced ends.
