Recovering Cottier's:

Approaches to Restoration and Interpretation in a Major Scheme of Painted Decoration in Glasgow's West End

David Robertson
Director, Four Acres Charitable Trust

Hilary Macartney
Research Associate, University of Glasgow

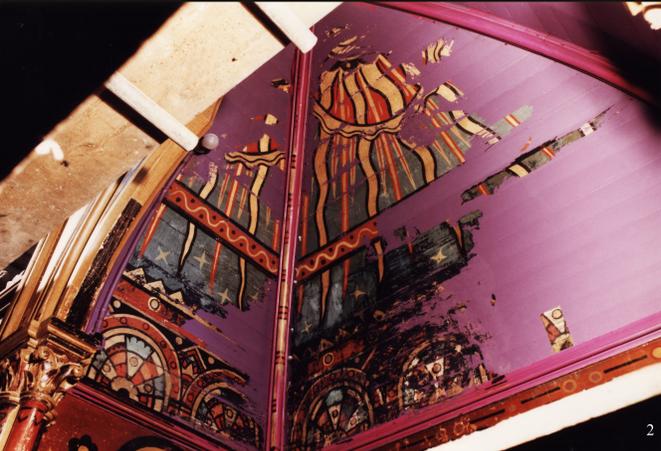
Captions: Fig. 1 Restoration and reconstruction of the Cottier scheme carried out in the choir and first bay of the nave, August 2012, prior to reinstallation of the organ. Photo: Alan Crumlish. Fig. 2 Underside of pulpit canopy with original flame decoration being uncovered in 1989 from under the 1960s emulsion paint. Photo: Historic Scotland. Fig. 3 Solubility tests carried out on ceiling above choir gallery, 2010. Photo: Tobit Curteis Associates. Fig. 4 Exposure of earlier schemes of decoration on clerestory nave wall, showing Celtic motif overlying original Cottier roundel, 1989. Photo: Historic Scotland. Fig. 5 Preparation of original decoration surface with protective intervention layer, prior to reconstruction of decorative scheme on south nave wall, August 2012. Photo: Hare & Humphries. Fig. 6 Reconstruction of decoration at upper section of south nave wall, with conserved ceiling decoration above, August 2012. Photo: Hare & Humphries.

1937: On the advice of the artist D.Y. Cameron, Celtic motifs replaced the original designs (fig. 4) but Cottier's scheme was again respected in many other ways, including the varnish applied to the ceiling (figs. 1,3) in an effort to preserve it. Nevertheless, the highly decorated pulpit (fig. 2) was covered over in wood-effect graining.

1960s: The whole Cottier scheme was covered over by plain emulsion paints in purple, turquoise and light blue (figs 1-3).

The recent work is the first full-scale project of restoration and reconstruction to date. The removal of the Willis organ, installed in 1876, for restoration enabled the original choir area and southernmost bay of the nave at gallery level to become the site of the first major phase of recovery of the decorative scheme since 1989 (figs. 1,5,6). The work is viewed as a pilot phase from which lessons will be learned for the whole interior.
