Stone Matching for Historic Buildings

Stone Decay – A Major Concern for Historic Buildings

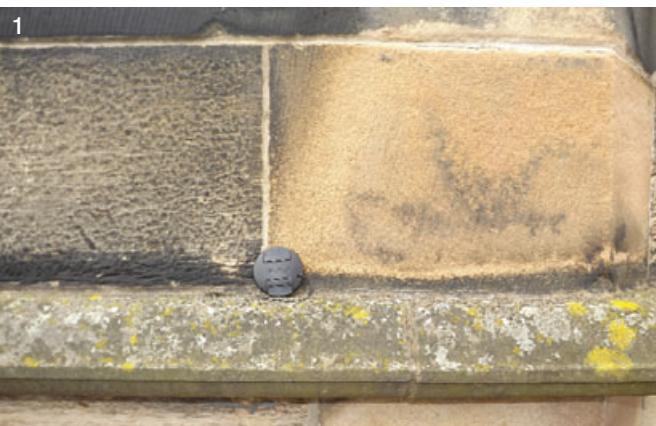
1. Building stones in states of decay – uncleaned (upper left); self-cleaned by rainwater (upper right); biologically encrusted (horizontal)
2. Carved piece of stone with weathering rind along its outside edge
3. Stone thin section with pore spaces impregnated by blue resin
4. Blocks of juxtaposed 'tooled' and 'untooled' building stones

Historic sandstone buildings throughout Scotland are decaying rapidly as a consequence of their age, together with the impact of long-term pollution from domestic coal burning and the industrial revolution era. This decay manifests itself either in the slow disintegration of the stone or by the catastrophic failure and collapse of parts of a facade. The optimal option is to completely replace the original stone, but unless the new stone is closely matched to the old one, repair may be harmful to the structure itself and the building's appearance can be compromised. Unfortunately, many of the original quarries are no longer in operation. Meanwhile, inappropriate interventions, such as stone cleaning, and poor quality repairs, such as mixing impervious, less porous cement materials with much softer sandstones, have already caused widespread damage to historical buildings that are now in urgent need of attention.
