S E R F

Scores Burn Farmstead 21th -22th August 2012 Survey Report

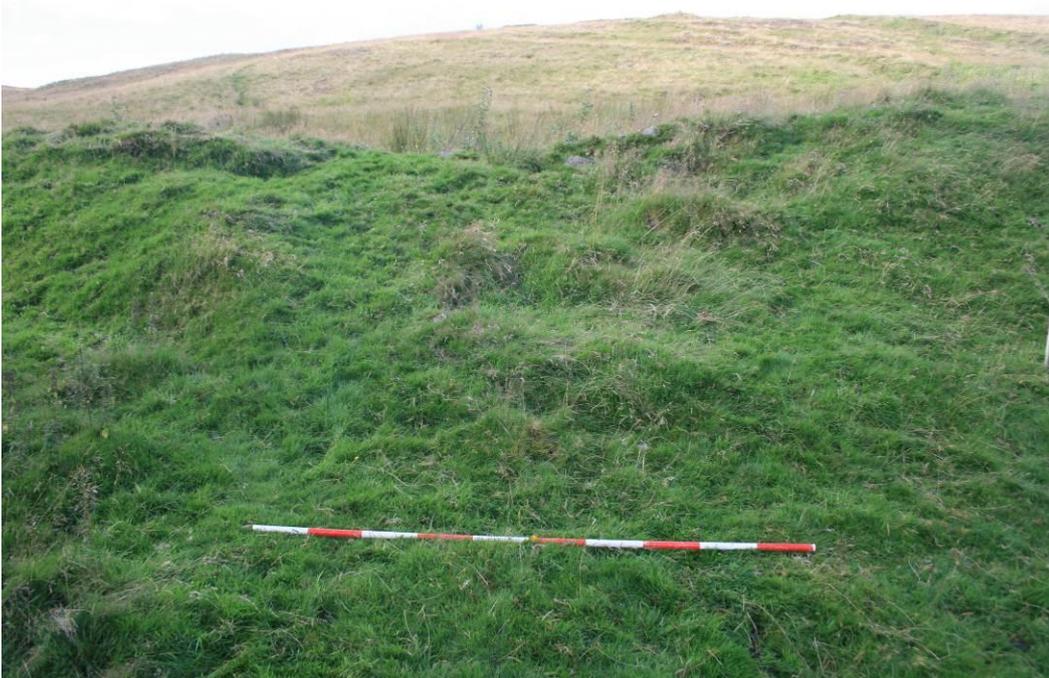
Building B comprises a rectangular structure which has been constructed within a small natural hillock. This building measures 6m by 5m over grass-grown stone footings and may have an entrance in the south-east corner. Surface remains suggest this building may contain a kiln bowl in the western end built into the natural slope. The possible kiln bowl appears to be offset slightly and aligned to the entrance, possibly suggesting that the flue may have been on the south-east and space for loading the corn-drying kiln was north-west of the kiln bowl.

Figure 4 (left) Photograph looking south-west into structure B, a possible kiln barn. This photograph illustrates the extremely ephemeral nature of the remains. Structural stone is visible in a slight dip in the centre of the top of the green bank. Slight banks running down the slope and a small bank below the ranging pole in the foreground define the structure. A slight hollow in the upper left of the structure may suggest the presence of the kiln bowl.

Excavation would confirm or disprove the interpretation of structure B as a possible kiln barn would also assist in understanding the site. If the structure did prove to be a kiln barn excavation would add to the small but important dataset which already exists on this important class of monuments (Dixon 2011).

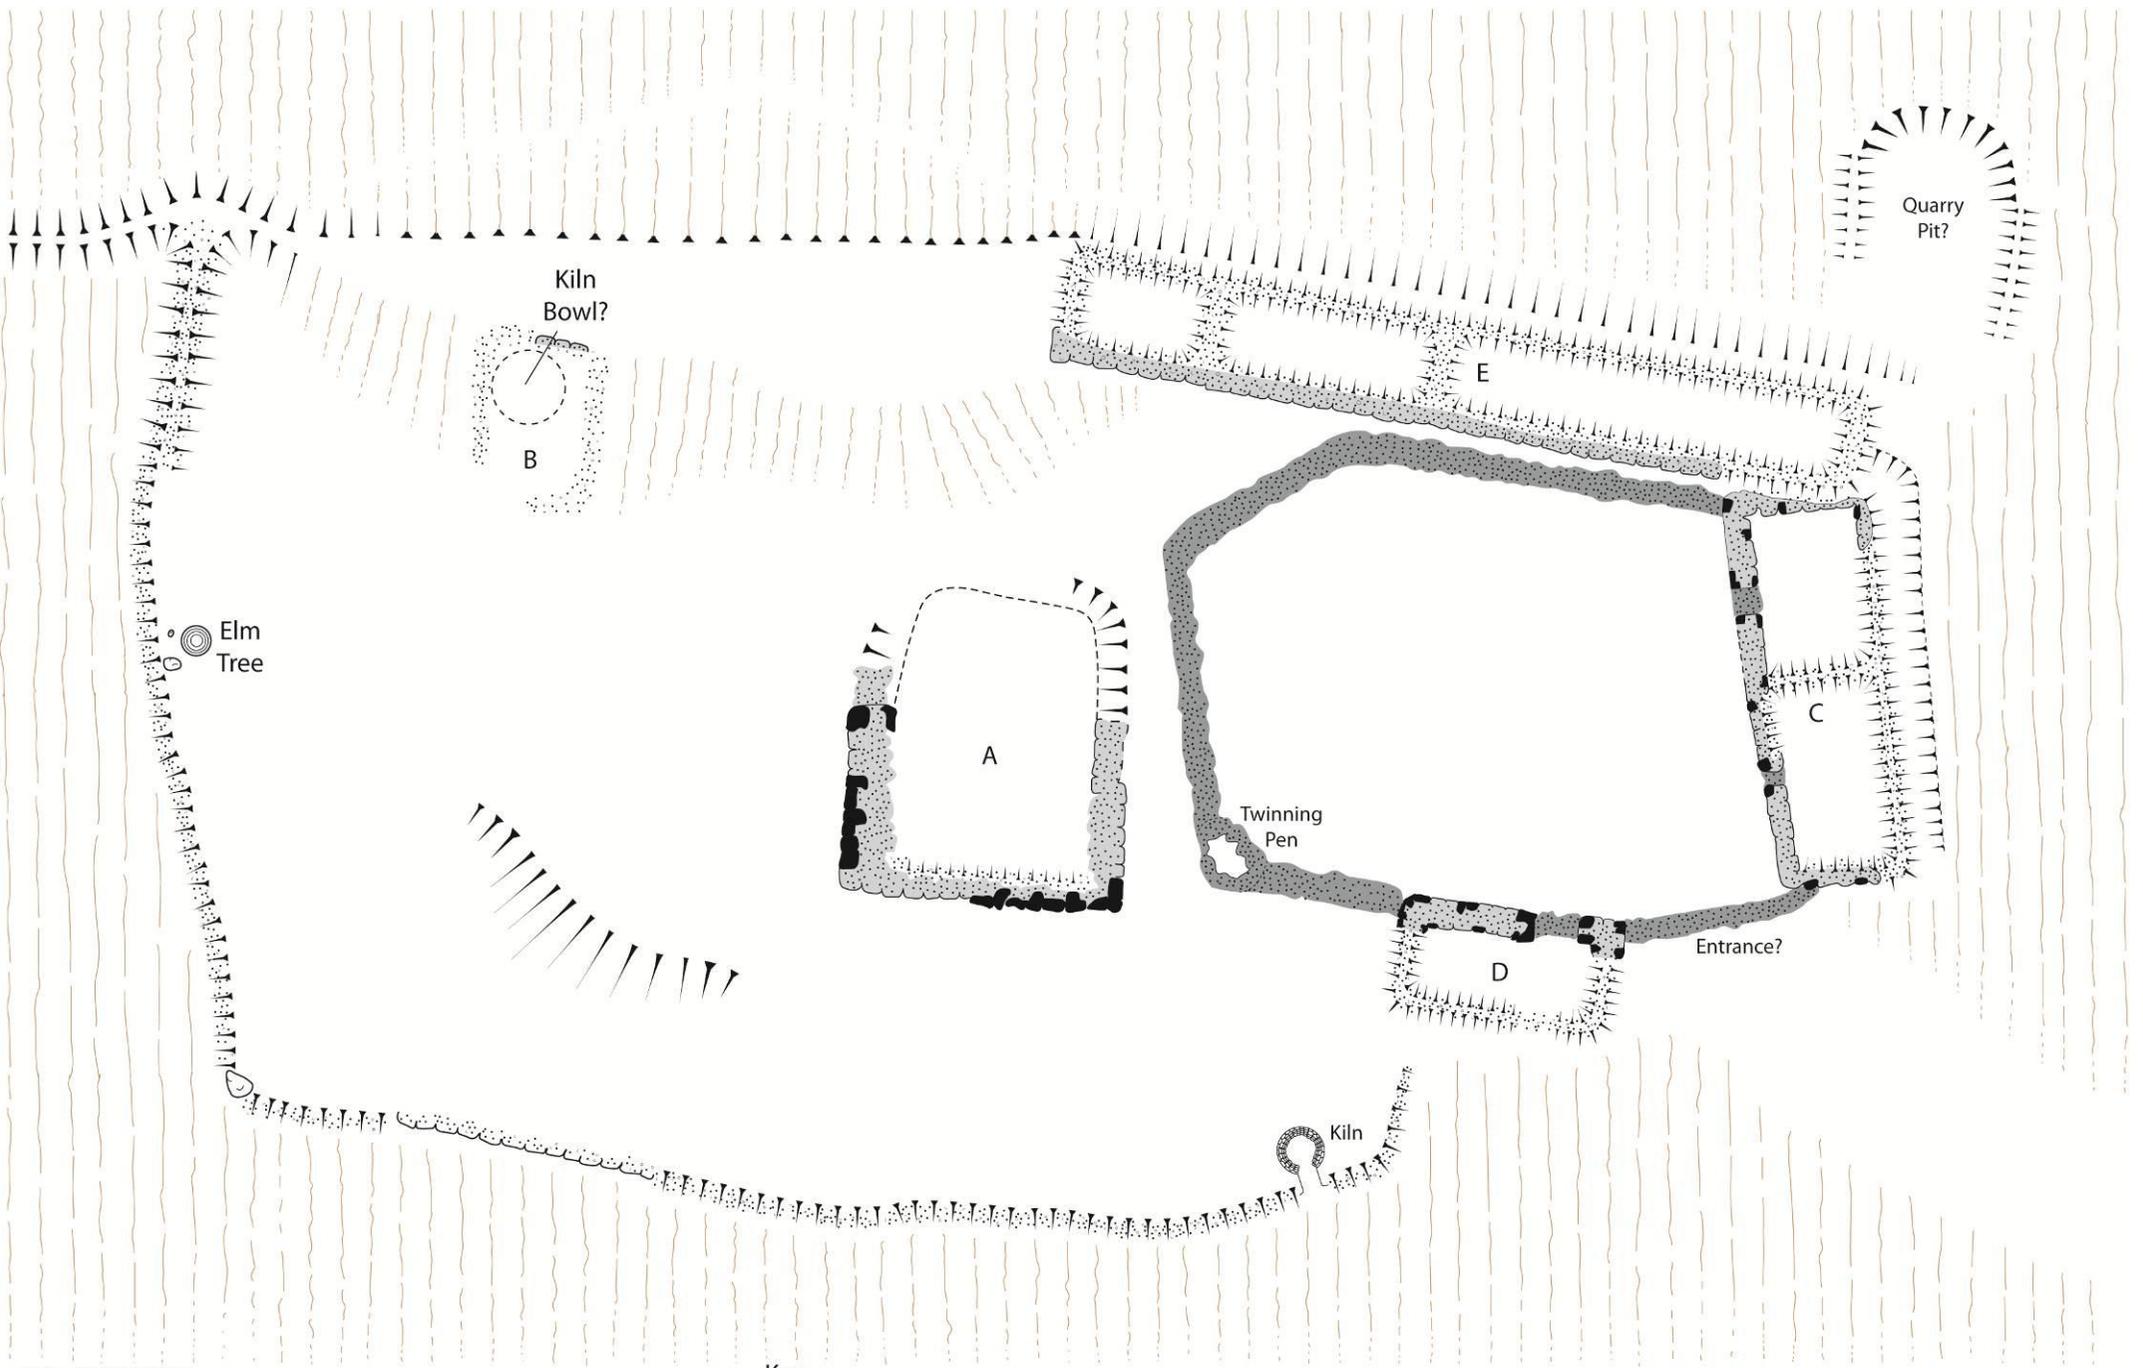
SERF 2012
 Scores Burn Farmstead, Perthshire
 Survey 1:250

The survey revealed the remains of five buildings, a corn drying kiln, an enclosure, and a later sheepfold. An annotated version of digitised survey can be seen overleaf (**Figure 3**).

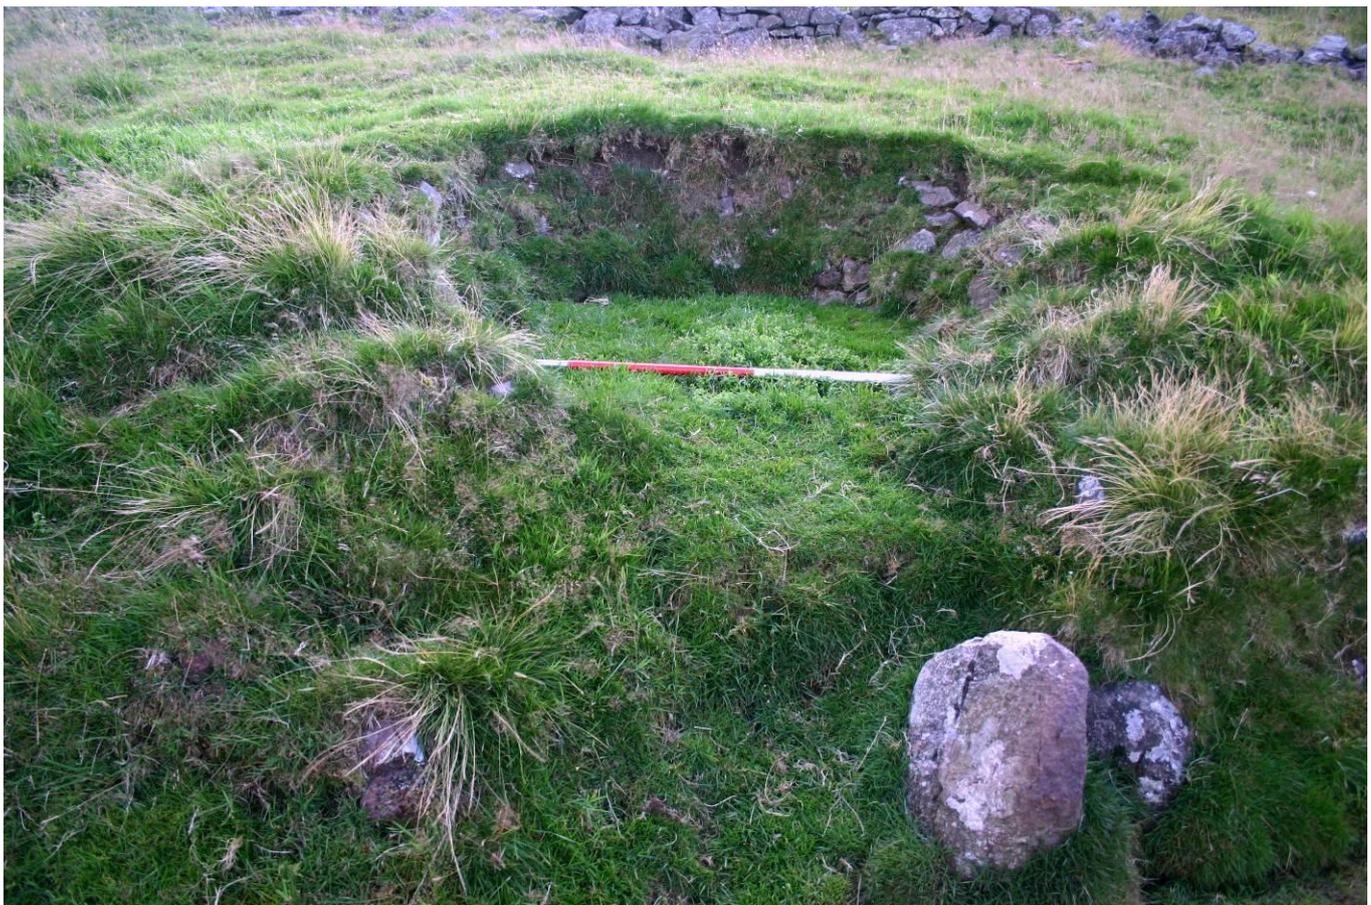
Approximately 9m to the south-east of building D are the remains of a corn drying kiln is built into the east wall of the revetted platform enclosing the south part of the farmstead. The kiln is constructed of angular stone and survives to a height of around 5 courses. The top of the kiln bowl is 1.5 m in diameter and c 0.7m at the narrowest visible point. The flue is not visible but appears to have been north-east facing. **Figure 5** (below) shows the remains of this structure. The stone structure of the kiln bowl is clearly visible and the collapsed stonework in the foreground is likely to have been part of the flue. © The Author.
