Castle Craig 2012

Data Structure Report 2012

Heather James with contributions by Ewan Campbell

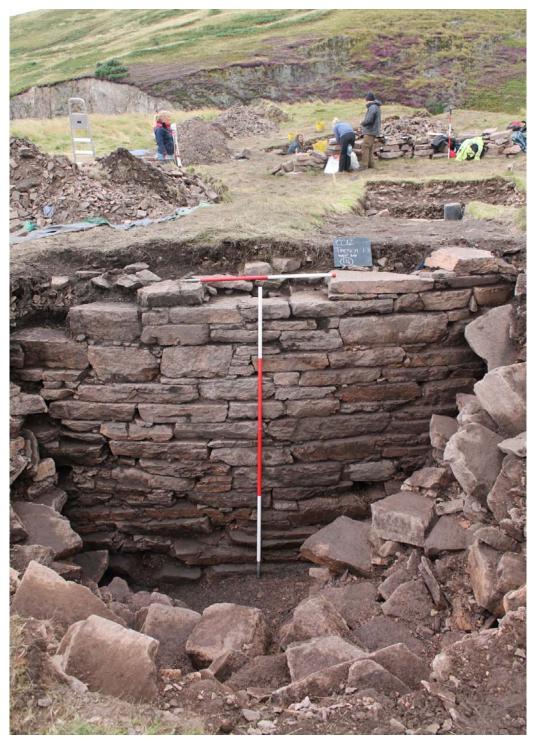
Plate 1 Outer face of the broch from the W.

The base of the outer wall face of the broch (114/016) was revealed at the W end of Trench 01. The wall face measured 2.2m high above the foundation course and was battered back by 0.50m. The basal foundation course of the wall was stepped out by 0.10m. The wall face was

constructed of 18 well-built courses of predominantly blocky rhyodacite (which naturally breaks into laminated blocks) and a few sandstones. The wall was generally in good condition with some small pinning stones still in place, however there were a few small gaps in the stonework towards the base of the wall where stones were damaged, as if crushed by weight from above.

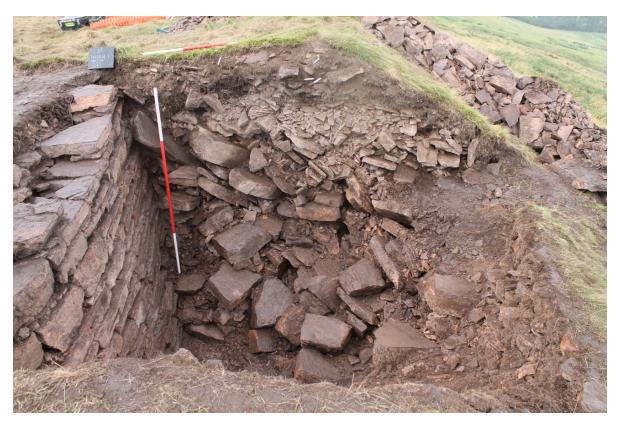
Plate 2 Vacuous rubble (110/049) abutting the broch wall.

The gravel (125) was sealed by a substantial deposit of vacuous rubble (110/045) which abutted the broch wall to a depth of 1.8m. The rubble (110/045) consisted of large blocky slabs up to 0.50m long which had come to rest at an angle of between 30 and 45 degrees, sloping away from the broch wall. The rubble (110/045) extended for at least 3m from the broch wall. A particularly large square stone (109) was seen in the S facing section and was initially thought to be part of a revetment, but as there were no other stones in line with it and so it was interpreted as part of the rubble (110). The large vacuous rubble was evidence of the rapid demolition of the outer face of the broch. There was no evidence for stabilisation horizons or old ground surfaces within this deposit, which might have suggested a gradual collapse over a period of time.

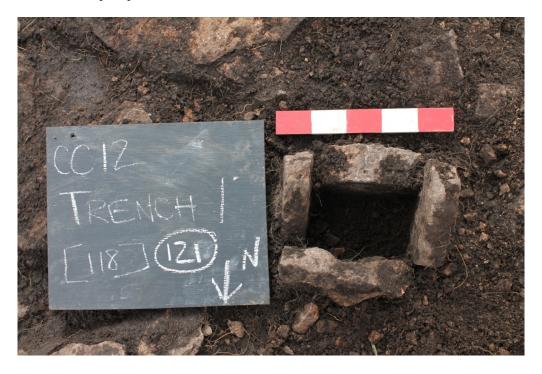
Plate 3 Post-setting (118/121)

A square setting of small upright stones (118) was seen immediately over the outer wall of the broch set within layer (117). The post-setting (118) was 0.22m wide and could have supported a squared post measuring about 0.18m by 0.15m. It was filled with dark brown clay, small stones and charcoal (121).

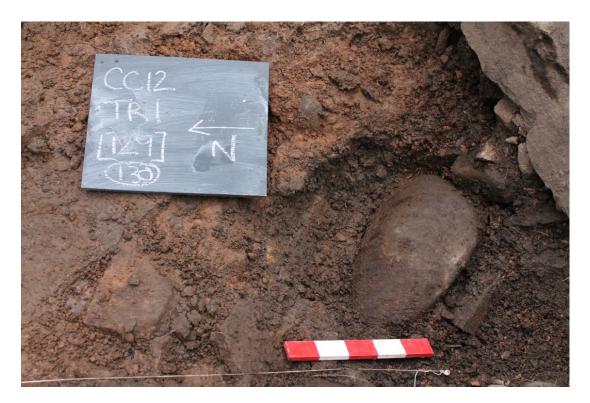
Plate 4 Post-hole by entrance to broch (129/130)

There was a circular post-hole (129/130) immediately within the entrance of the broch, which was not sealed by the floor slabs. The post-hole (129/13) measured 0.36m in diameter and was 0.09m deep. There was a large water-rolled stone within the post-hole which was probably a packing stone for a timber post. As the post-hole was not sealed by the slabs and it could have been in contemporary use.

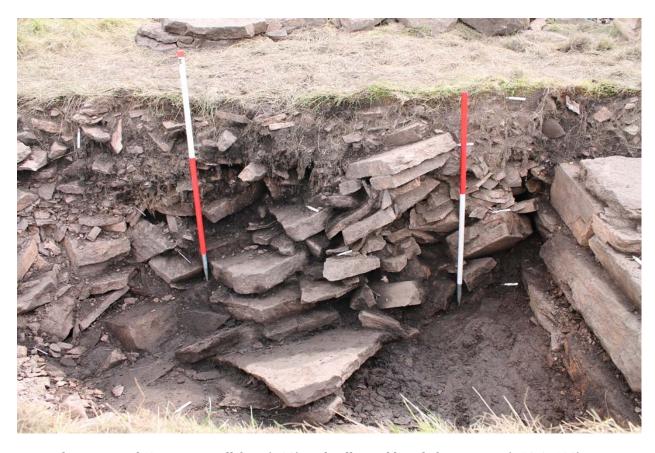
Plate 7 Trench 06, outer wall face (603) and collapsed broch face stones (613 & 618)

The outer face (603) was 0.7m high and consisted of five courses of both flat slabs and large blocks (see Plate 7). The basal stone was stepped out by about 0.10m and sat directly on bedrock. The wall was battered back. The core of the wall (619) consisted of large angular stones which varied in size, but were all fairly flat and well laid. The stones (619) contained a single slag fragment (SF 6345).

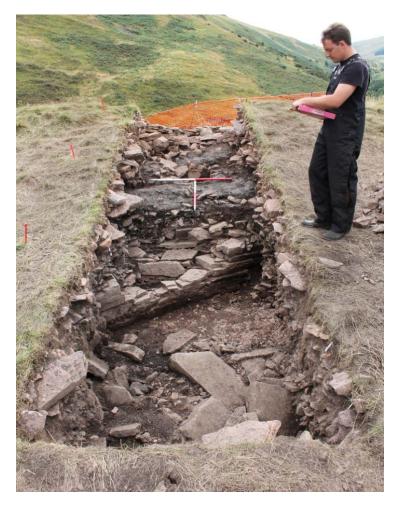
Plate 8 Trench 08, inner wall face (820)

The inner wall face (820) was exposed for between 0.20m and 0.50m in height and consisted of up to seven courses of flat slabs and angular blocks (see Plate 8). The base of this inner wall face was not revealed.

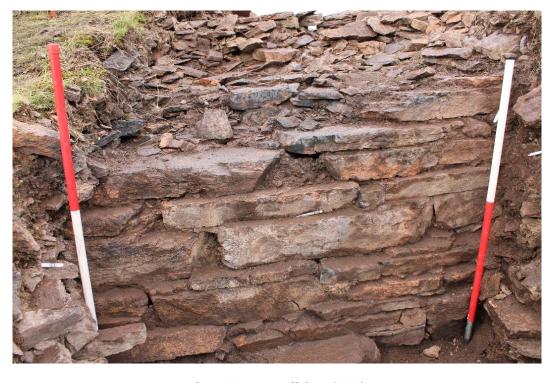
Plate 9 Outer wall face (809)

The outer face (809) was up to 1.05m high and consisted of ten, well-constructed courses of flat slabs and large boulders sitting on natural subsoil (824) (see Plate 9). A single large stone (814) protruded from the base of the wall by about 0.15m. The wall face (809) was battered in a similar way to the outer face in Trench 01.

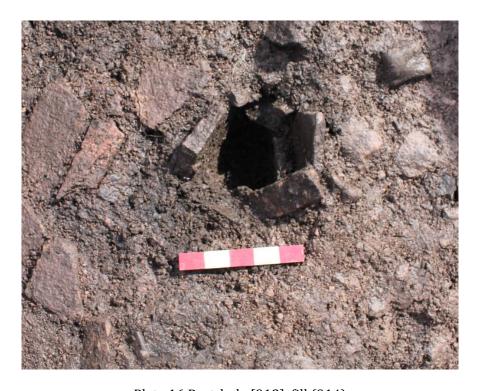
Plate 16 Post-hole [913], fill (914)

A small posthole [913], fill (912) was cut into the dark clay (910) and lined with upright slabs on three sides (see Plate 16). This post-hole lay about 1.0m S of the wall and would have supported a post about 0.15m in diameter. Another larger vertical slab was exposed to the E, and may have been another post-hole, but this lay outside the excavated area.
